# **Hazardous Materials Survey Report**

## **Administration Areas of Building 728 (Aircraft Maintenance Hanger Building) Marine Corps Air Station Beaufort, South Carolina**

**KCI Associates of North Carolina, P.A.  
Landmark Center II, Suite 220  
4601 Six Forks Road  
Raleigh, NC 27609  
KCI Project: 10110414F**

August 18, 2011

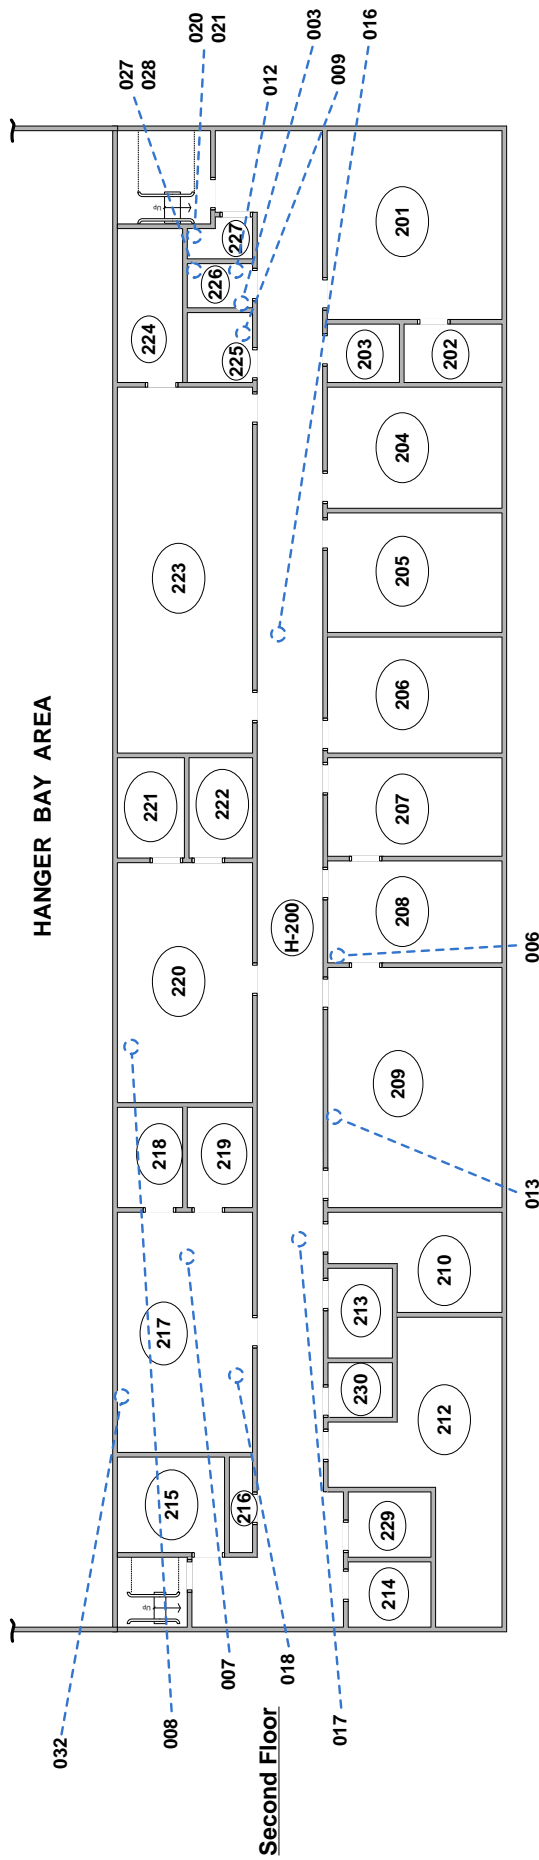
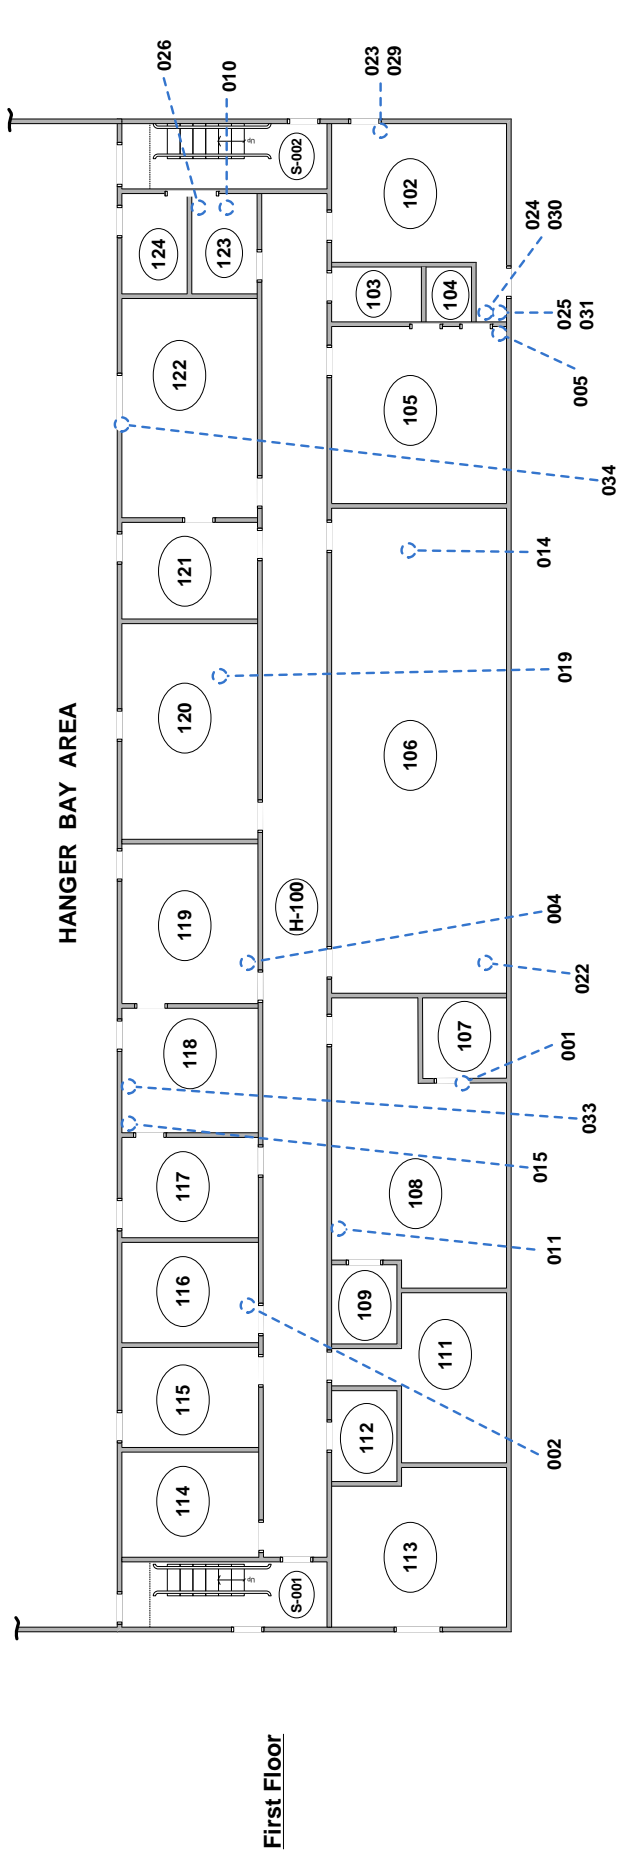
**SMALL BUSINESS GROUP, INC.**  
 Asbestos Sample Location - Building 728 Admin Areas  
 Marine Corps Air Station - Beaufort, SC  
 Date: 5/25/10  
 Scale: None  
 Page 1 of 1

**NOTE**  
 No Asbestos Containing Materials above the 1% limit were detected in the building
